SUBJECT: **Surface Mining Permit No. 86-137-(4)**
HO Meeting: May 17, 2016
Agenda Item: No. 10

10-YEAR RECLAMATION PLAN PROGRESS REPORT 2016

**Empire Quarry
Two Harbors, CA**

CA Mine ID #91-19-0011

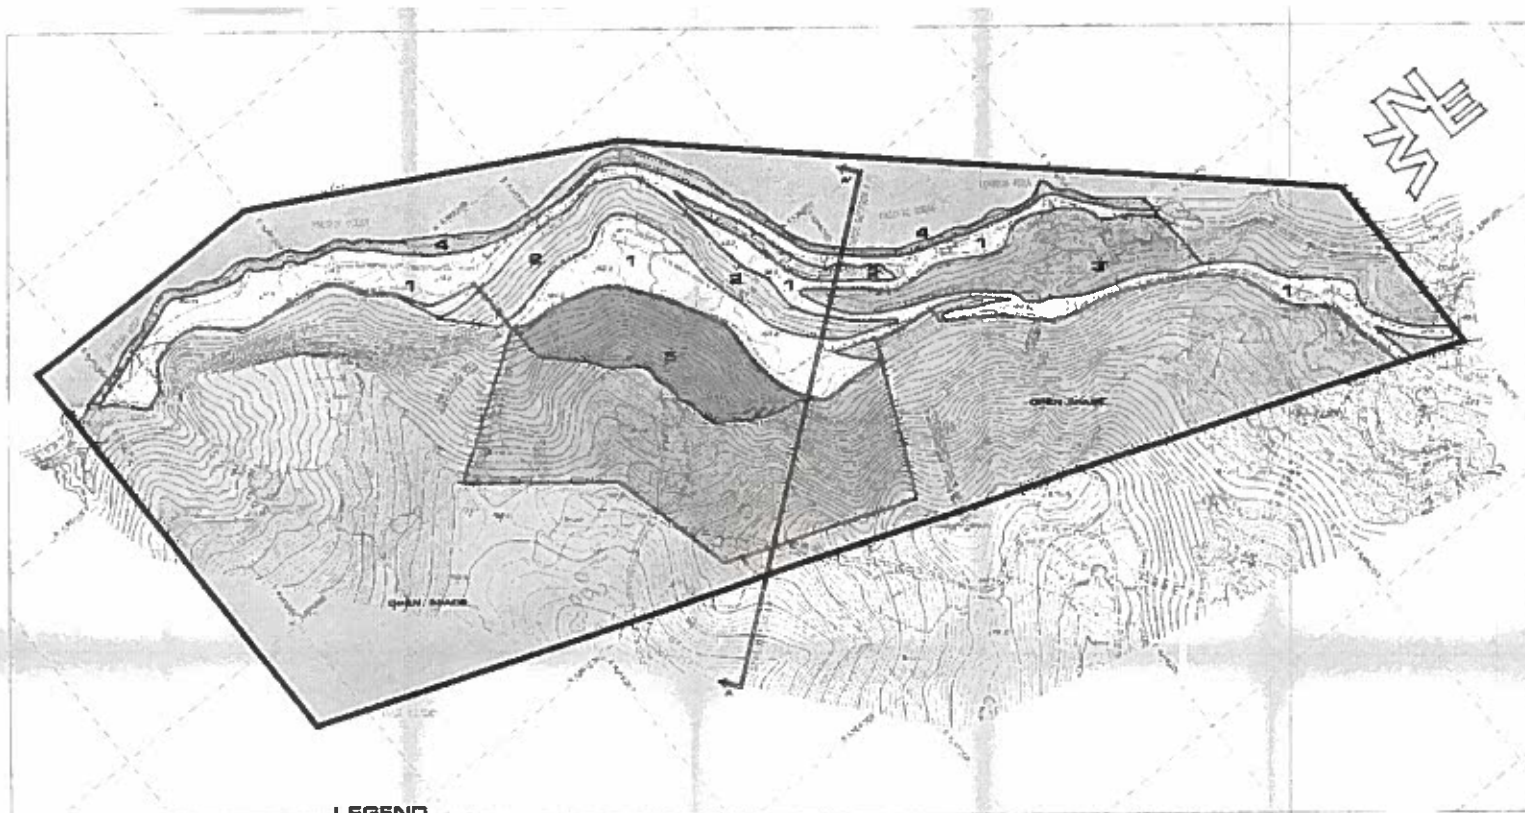
- 1 PRODUCTION AREA (ROCK SUBBASE), STOCKPILE, HAUL ROADS, LOADING, ETC.
- 2 ROCK CORE BENCH
- 3 ROCK CORE BENCH WITH UNCONSOLIDATED FACE COVER
- 4 SHORE LINE SLOPE FACE
- 5 PRODUCTION WALL & SLUMP PILE

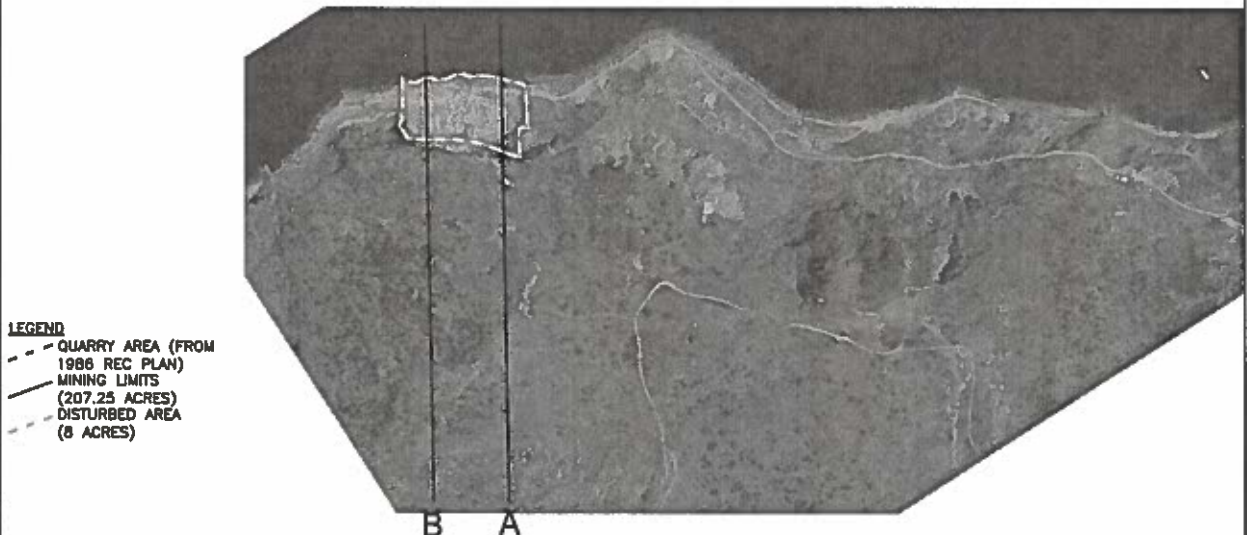
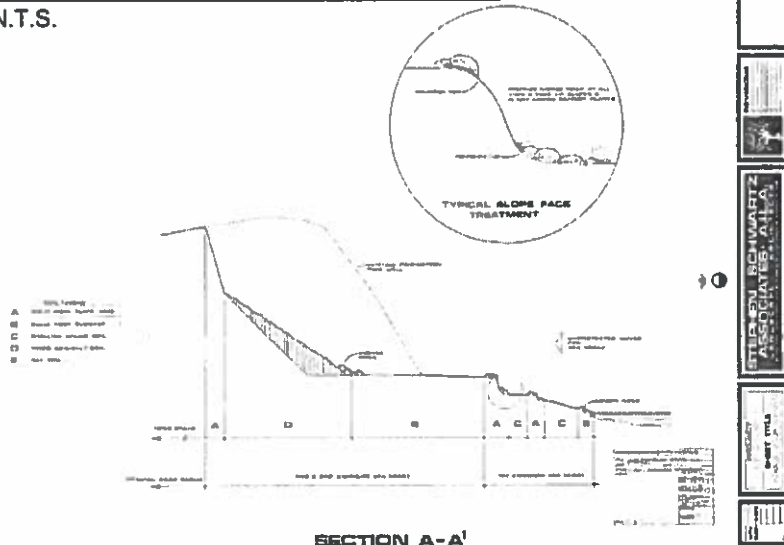
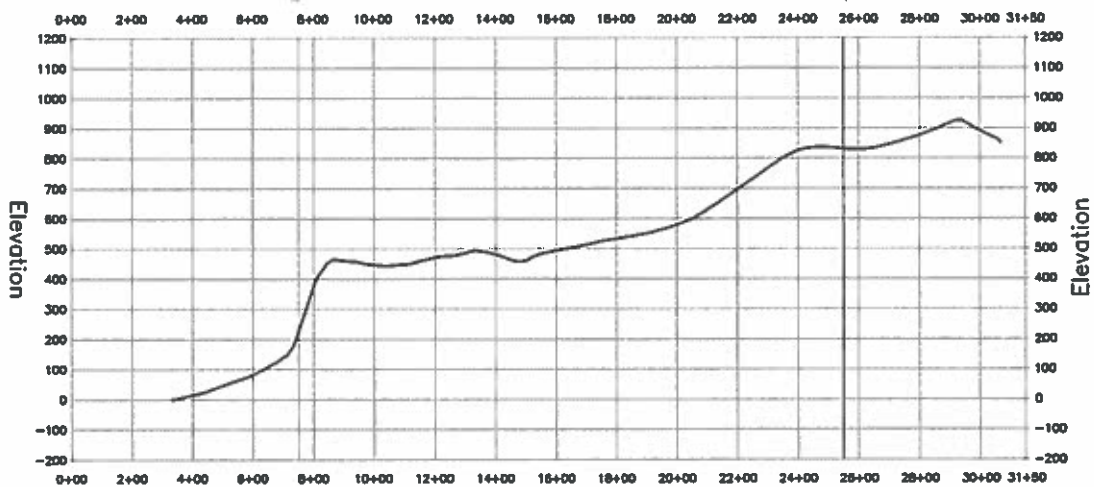
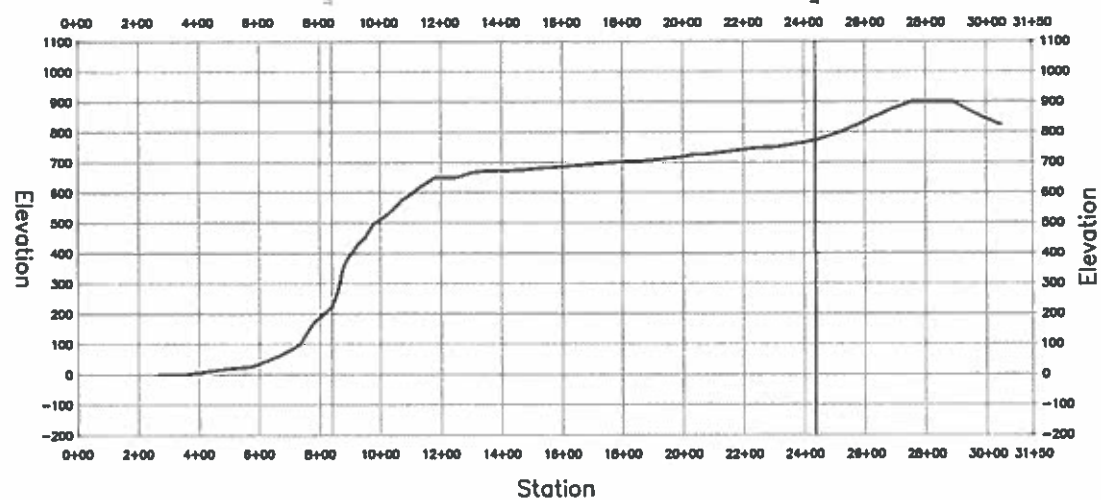
CONNOLLY-PACIFIC CO. EMPIRE QUARRY RECLAMATION PROGRESS REPORT SITE PLAN COMPARISON			
DATE	BY	CHECKED	DATE
	DAVID SM		
	DEVIN MOORE		
FIGURE NUMBER			3

**1986 Reclamation Plan vs. 2015 Survey Comparison Figures
Site Photos (February 16, 2016)**

1986 RECLAMATION SITE PLAN

CURRENT CONDITIONS

SECTION A-A'

Profile View of B

Profile View of A

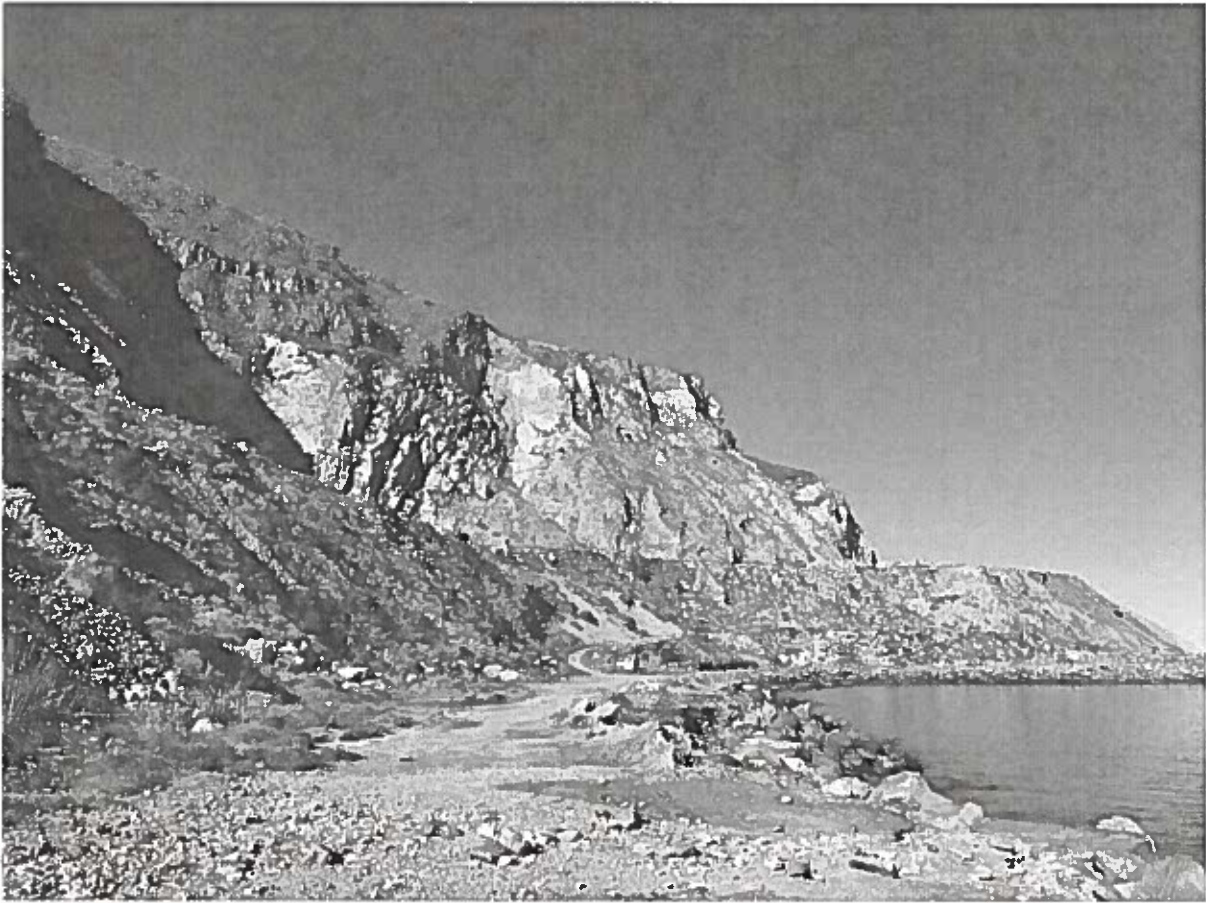
Photograph 1: Quarry benches and processing / loading area, facing northwest. Shore line slopes are lined with armor rock protection to reduce excessive erosion, and natural revegetation has occurred in most historical mining disturbances. (02/16/16)

Shore line slopes are required to be graded no steeper than 1:1 and protected from excessive erosion by armor rock. The shore line slopes that were observed during the site visit appeared to meet these requirements (see Photograph 1 and 2 in Appendix 2).

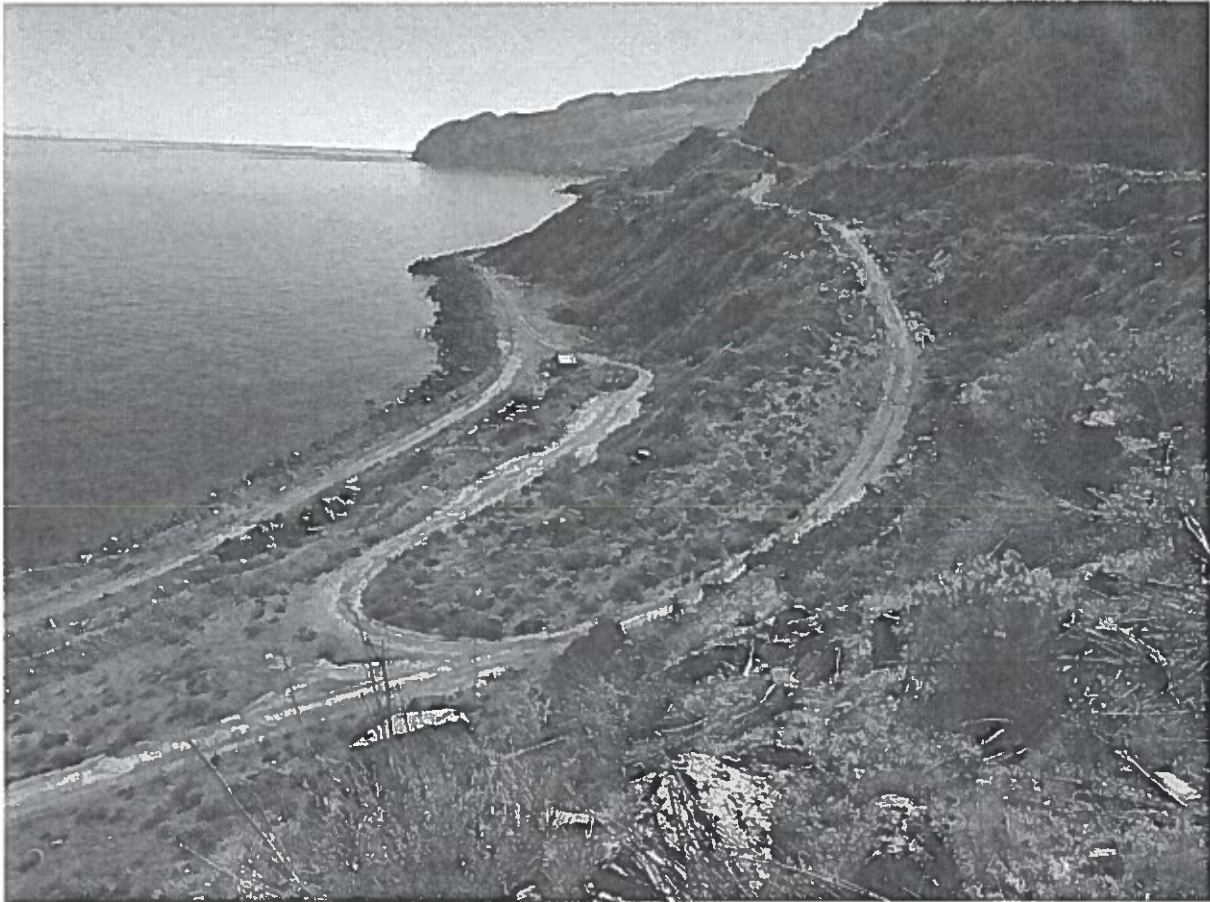
Photograph 2: Historic mining disturbance covered by natural revegetation, facing southeast. Shore line slopes are lined with armor rock protection to reduce excessive erosion. (02/16/16)

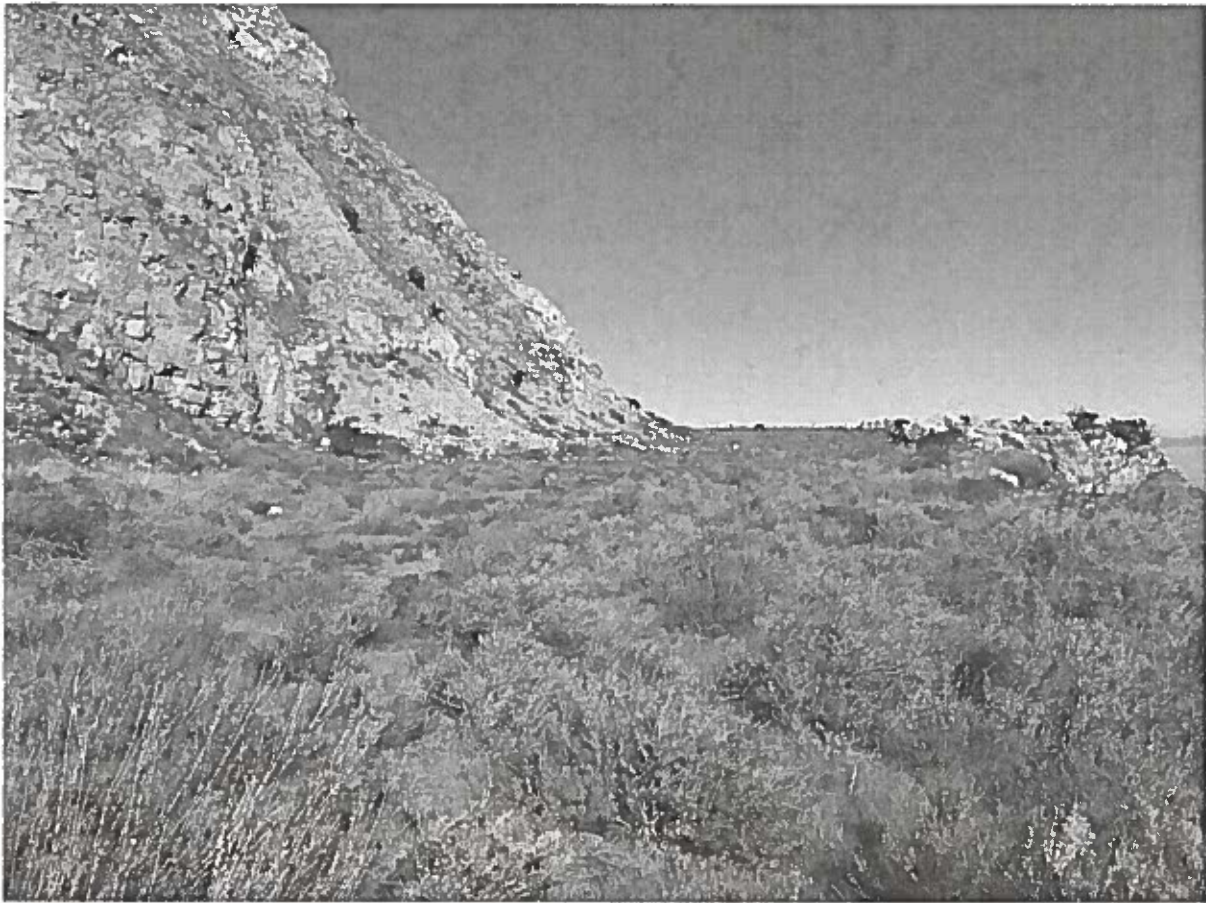
Photograph 3: Historic mining disturbance covered by natural revegetation, facing north. (02/16/16)

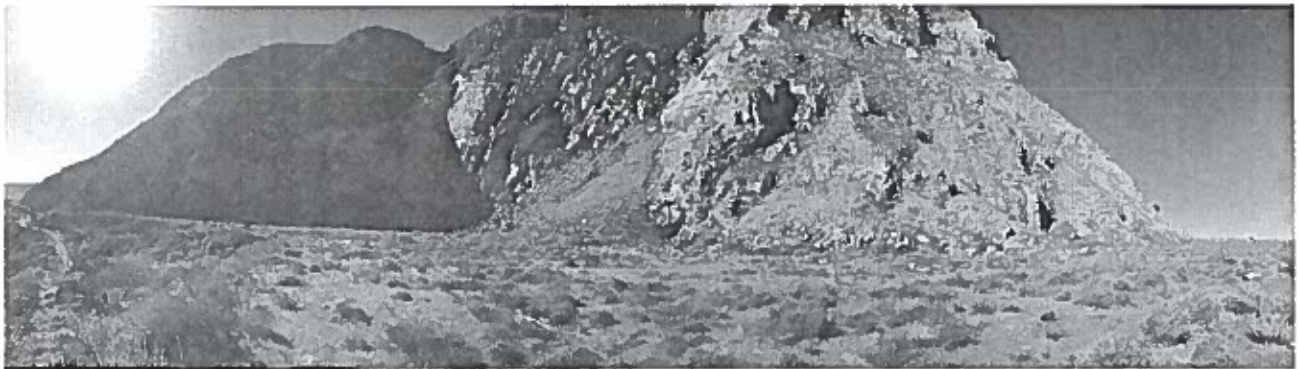
Photograph 4: Historic mining disturbance (processing area and high walls) covered by natural revegetation, facing west. (02/16/16)

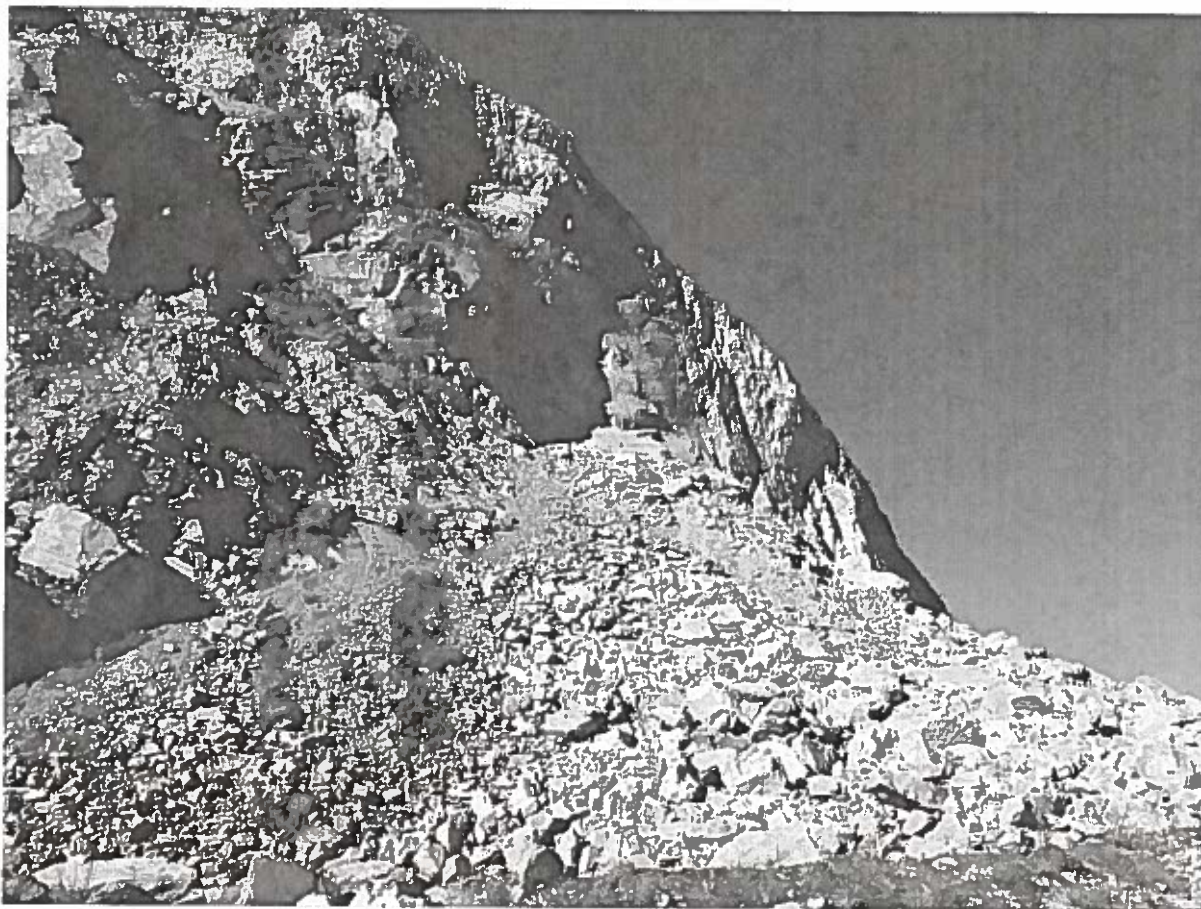
Photograph 5: Slide area, facing northwest. (02/16/16)

There is a slide within the reclamation area that occurred sometime between 2010 and 2011. The Operator indicated they were not mining the site at the time of the slide. The slide blocks off access the west end of the site. The operator will clear a path though this area when needed. They will be careful not to disturb the toe of the slide. Discussions with Los Angeles County Geologist indicate this type of slide along the Coastline of Catalina is not uncommon. Therefore, the violation has been removed from this report.

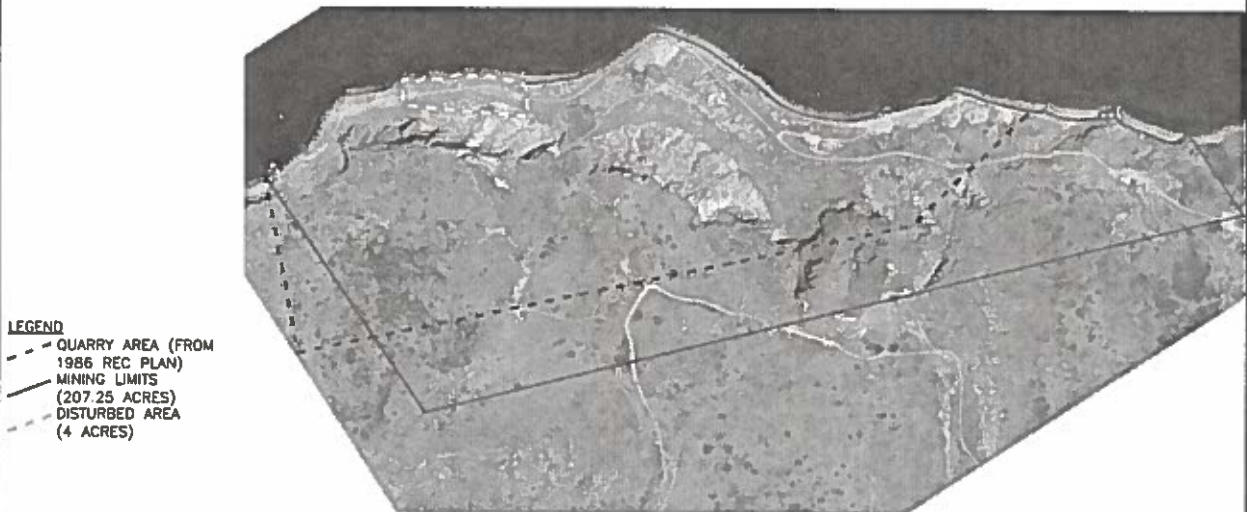
2006 Supporting Documentation 1986 Reclamation Plan vs. 2007 Aerial Photograph

1986 RECLAMATION SITE PLAN

2007 CONDITIONS

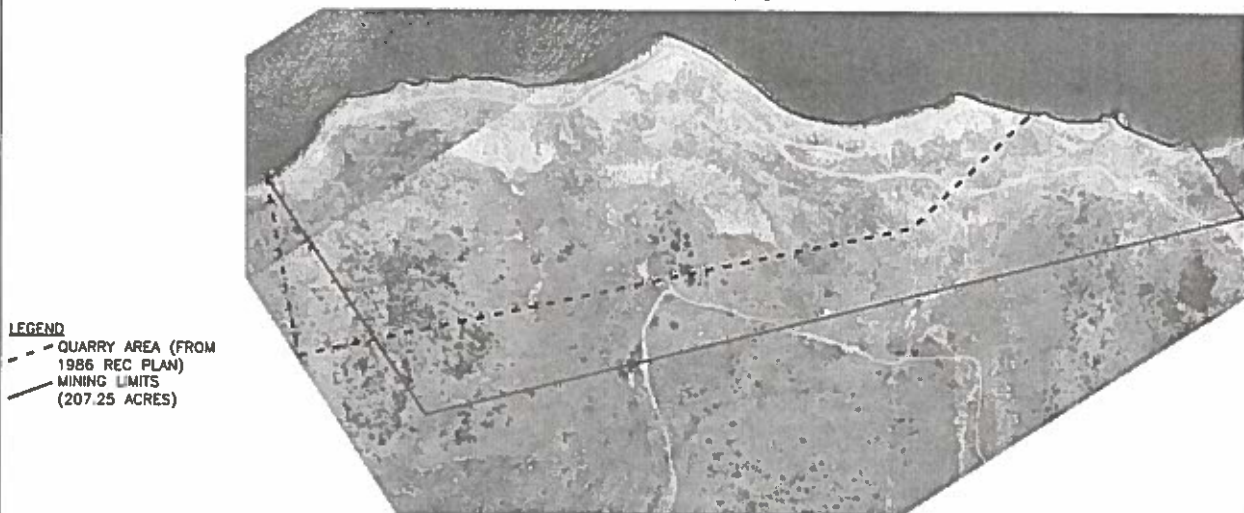
1986 Reclamation Plan vs. 1994 Aerial Photograph
Letter to the Department of Conservation dated February 3, 1997

1986 RECLAMATION SITE PLAN

1994 CONDITIONS
